# Asbestos Survey and Limited Lead-Based Paint Survey

Hannibal Machine  
400 South 11<sup>th</sup> Street  
Hannibal, Marion County, Missouri

January 28, 2011

Terracon Project No. 15107089

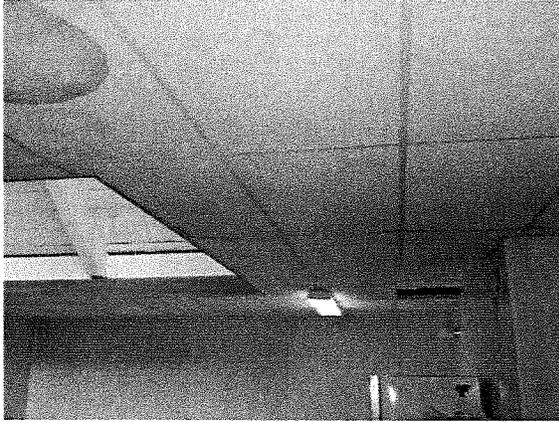
**Photo #1** HA 1 – 2'x4' ceiling tile

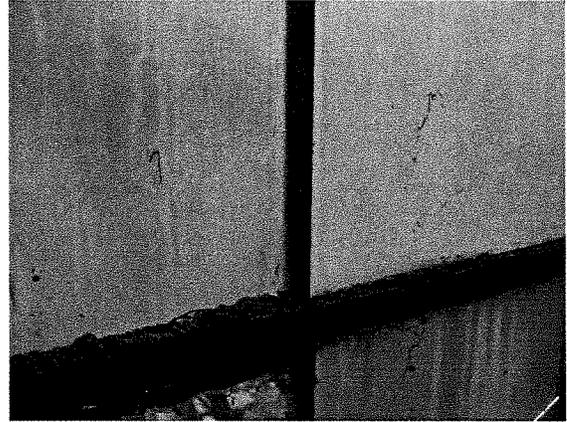
- Window glazing
- Awning roof over loading dock

<b>HA No.</b>	<b>Description</b>	<b>Material Location</b>	<b>Percent/Type Asbestos</b>	<b>NESHAP Classification</b>	<b>Condition</b>	<b>Estimated Quantity</b>
2	Window glazing	Shop office	2% Chrysotile	Category II non-friable	Damaged	10,000 LF
5	Loading dock roof	Loading dock roof	19% Chrysotile	Category II non-friable	Good	2,200 SF

**Photo #2** HA 2 – window glazing

It is recommended that the identified ACM at the site be managed in place with an Operations and Maintenance (O&M) Plan. ACM that will be disturbed during future renovation or demolition activities should be properly removed and disposed by a trained and licensed abatement contractor.

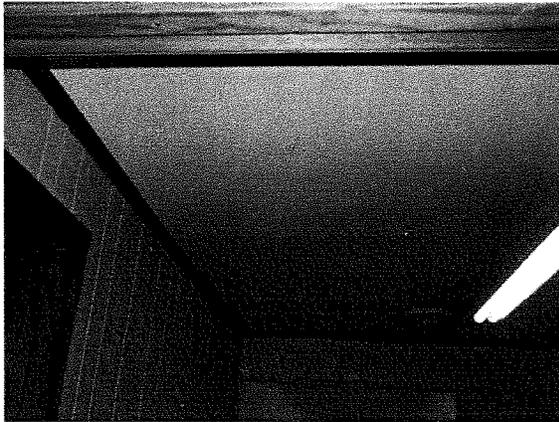
**Photo #3** HA 3 – drywall ceiling in office

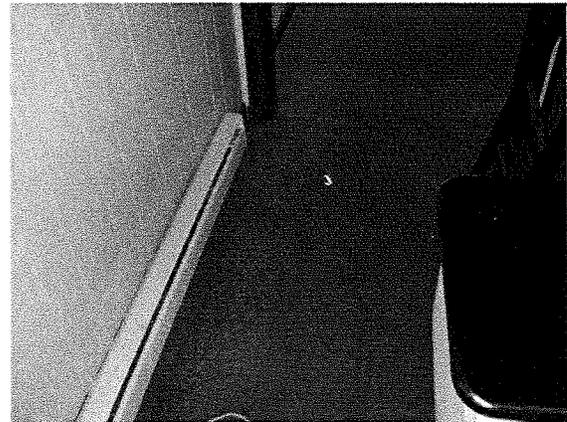
**Photo #4** HA 4 – carpet adhesive in office

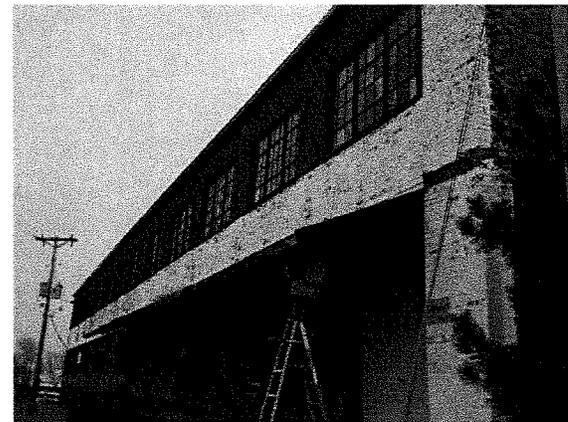
**Photo #12** HA 5 – loading dock roof
