Asbestos Survey and Limited Lead-Based Paint Survey

Commercial Building

527 South Main Street

Terracon Project No. 15107089

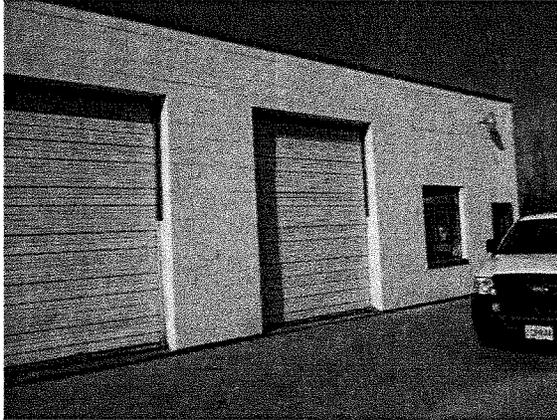
Photo #1 View of exterior of site building

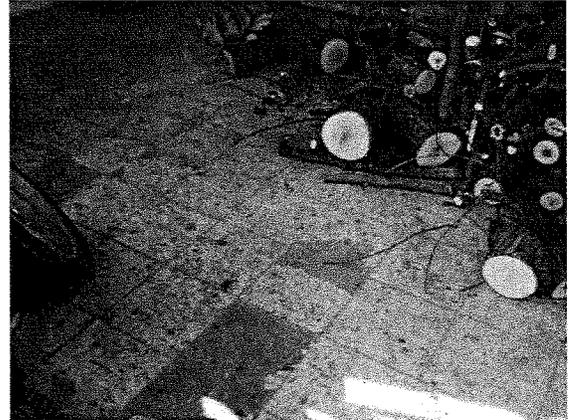
Photo #2 HA 3 – 12"x12" floor tile in office

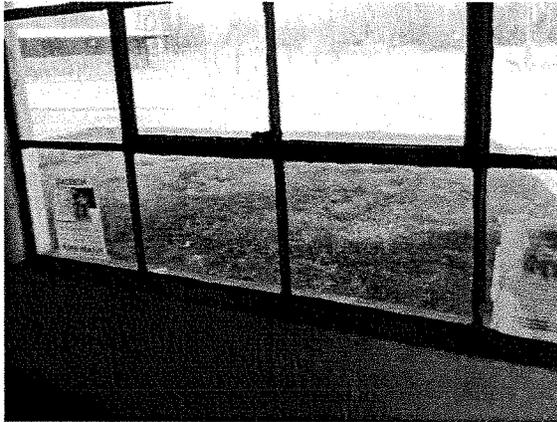
- Cement board
- Window glazing

Photo #3 HA 6 – window glazing

It is recommended that the identified ACM at the site be managed in place with an Operations and Maintenance (O&M) Plan. ACM that will be disturbed during future renovation or demolition activities should be properly removed and disposed by a trained and licensed abatement contractor.

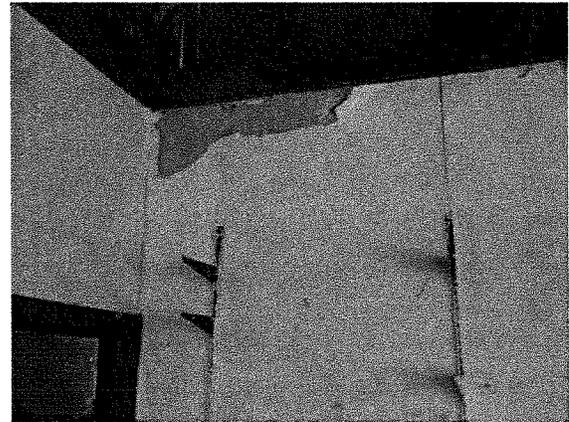
Photo #4 HA 1 – cement board in office

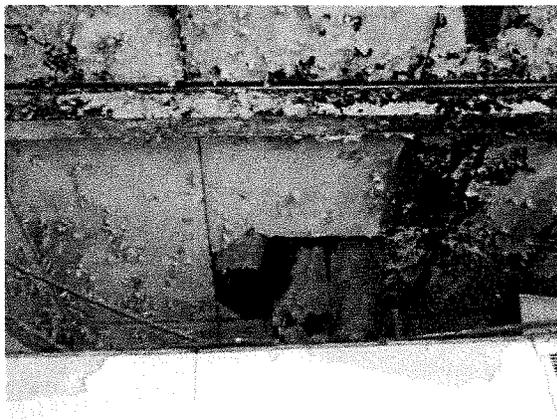
The interior and exterior painted components were in generally fair to intact condition with evidence of weathering. Terracon did not observe painted components which exhibited deterioration as defined in Section 3.2; and therefore did not collect samples of painted materials for TCLP analysis.

Photo #5 View of interior ceiling with flaking paint

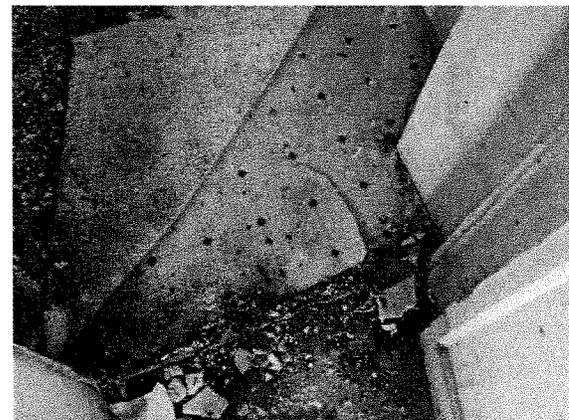
Photo #6 HA 5 – sheet vinyl flooring in restroom

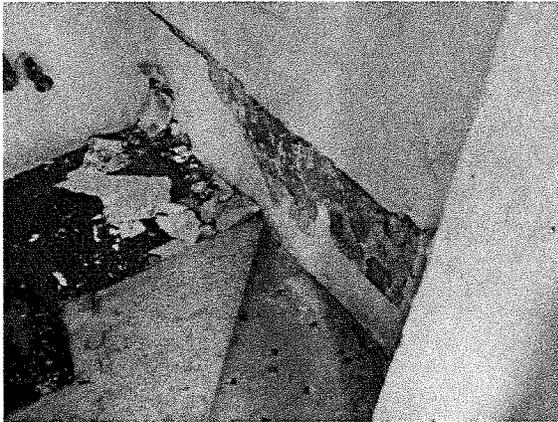
Photo #7 HA 4 – skim coat on block wall of restroom and HA – 2 drywall in restroom

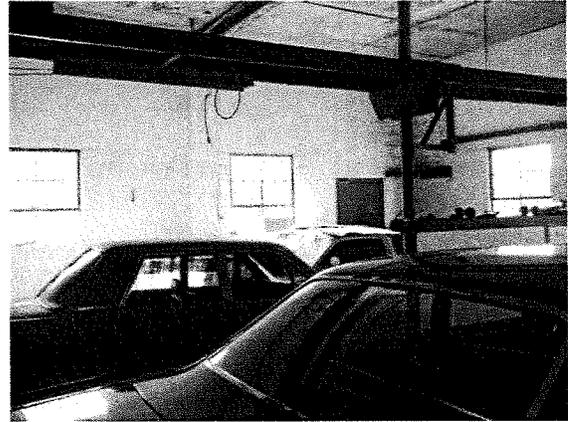
Photo #8 View shop

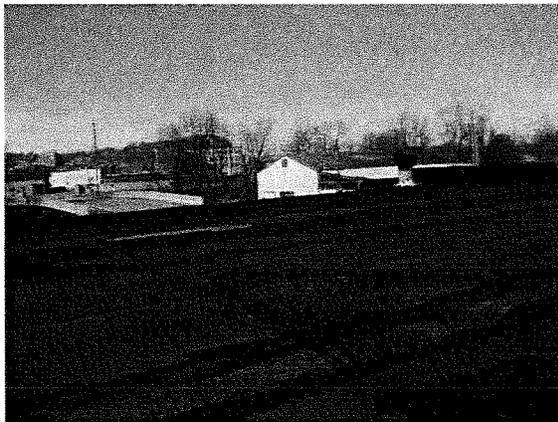
Photo #9 HA 7 – roofing (built-up)
