# Asbestos Survey and Limited Lead-Based Paint Survey

Commercial Buildings A, B, and C  
613 Munger Street  
Hannibal, Marion County, Missouri

February 16, 2011

Terracon Project No. 15107089

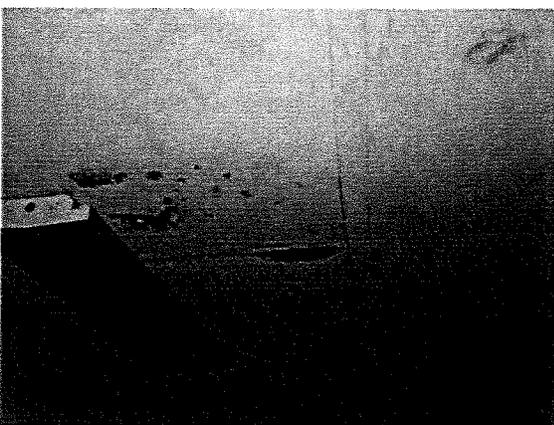
Photo #5 HA 1 (Building B) - drywall on ceiling of offices

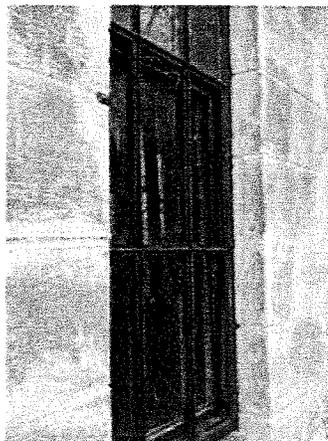
Photo #7 HA 2 (Building B) – window glazing

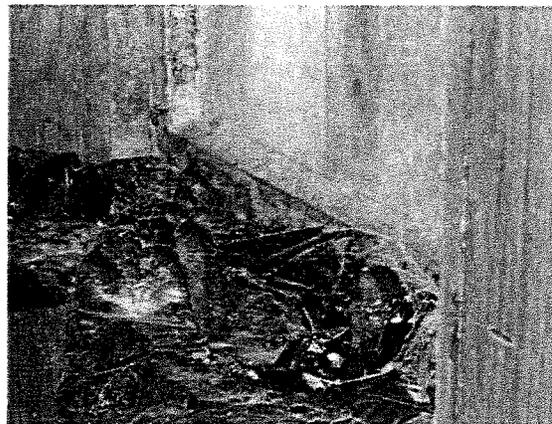
Photo #8 HA 2 (Building B) – window glazing

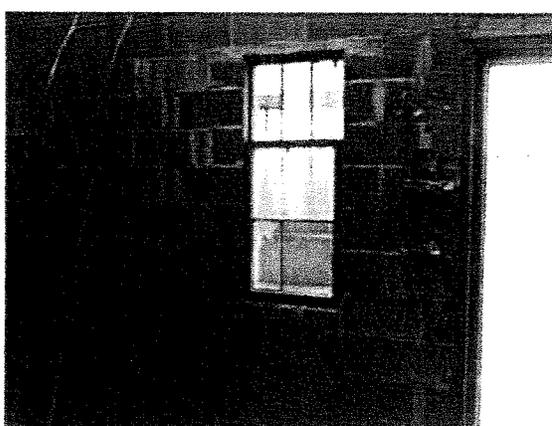
Photo #12 HA 6 (Building C) – window glazing

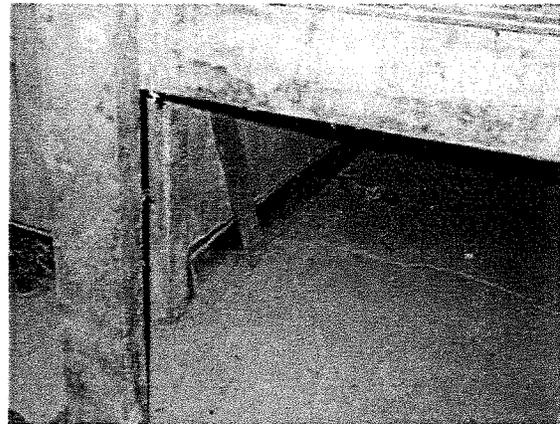
Photo #10 HA 2 (Building C) – baseboard mastic

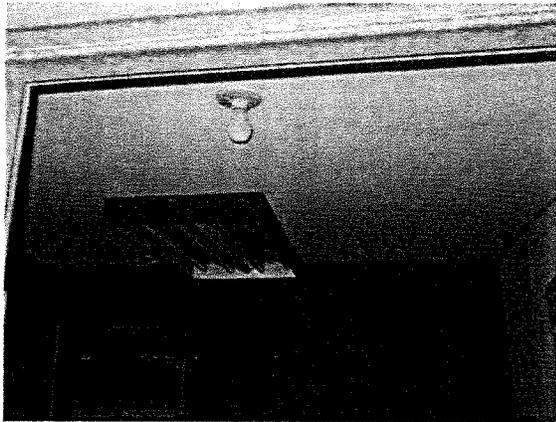
Photo #13 HA 3 (Building C) – drywall and joint compound

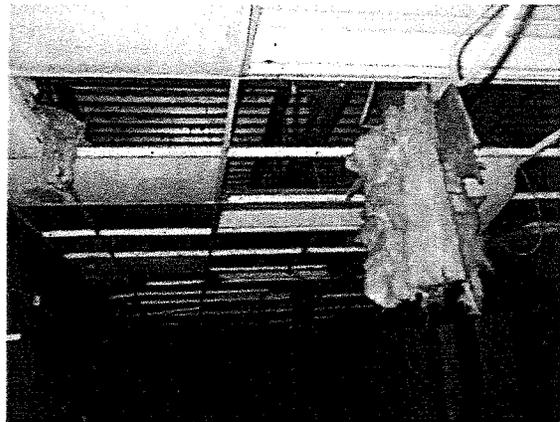
Photo #14 HA 5 (Building C) – 2'x4' ceiling tile

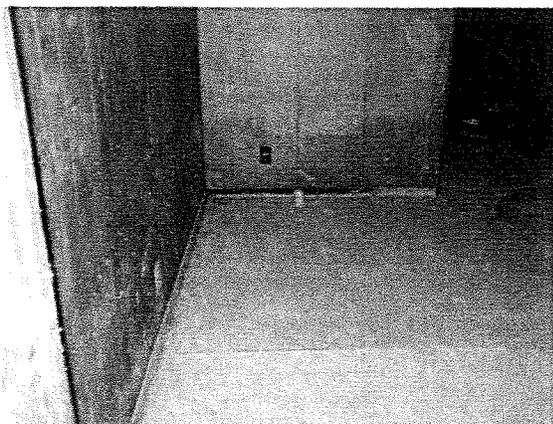
HA No.	Description	Material Location	Percent/Type Asbestos	NESHAP Classification	Condition	Estimated Quantity
1	Cement board	Mechanical rooms	19% Chrysotile	Category II non-friable	Good	2,000 SF
4	Sheet vinyl flooring	Offices	20% Chrysotile	Category I non-friable	Good	600 SF
7	Roofing	Roof	Assumed	Category I non-friable	Good	5,500 SF

Photo #15 HA 4 (Building C) – flooring in offices

The abatement of approximately 2,000 square feet of cement asbestos board and 600 square feet of sheet vinyl flooring may cost between \$9,000 and \$11,000. The 5,500 square feet of assumed asphaltic roofing can remain on Building C during demolition as long as the material is in good condition and is not made friable during removal or demolition.
