Asbestos Survey and Limited Lead-Based Paint Survey

Former Auto Repair Shop
700-702 South Main Street
Hannibal, Marion County, Missouri

January 28, 2011

Terracon Project No. 15107089

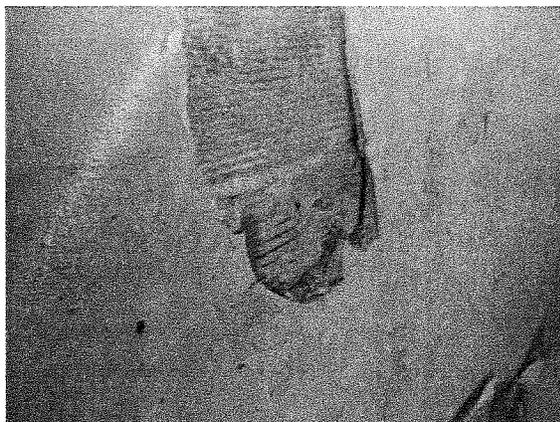
Photo #1 HA 1 – wall plaster

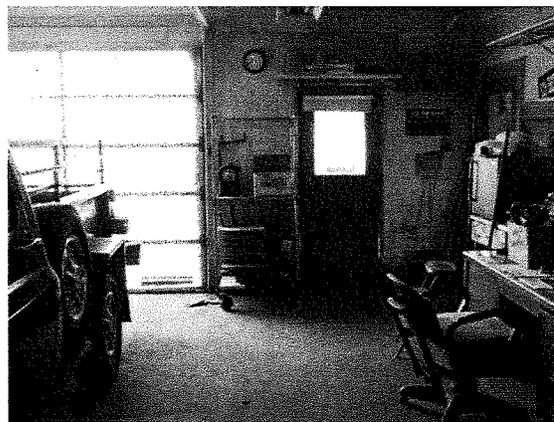
Photo #2 View of western portion of former auto repair shop

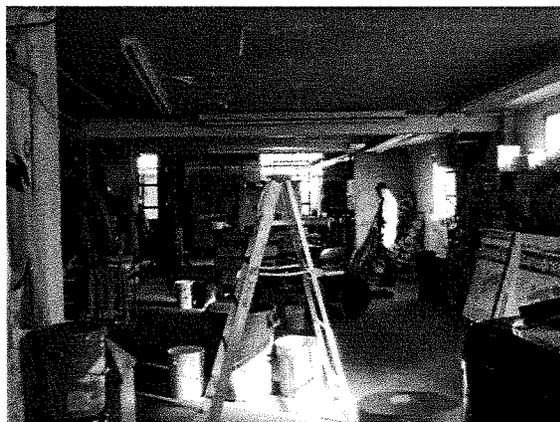
Photo #3 View of eastern portion of auto repair shop

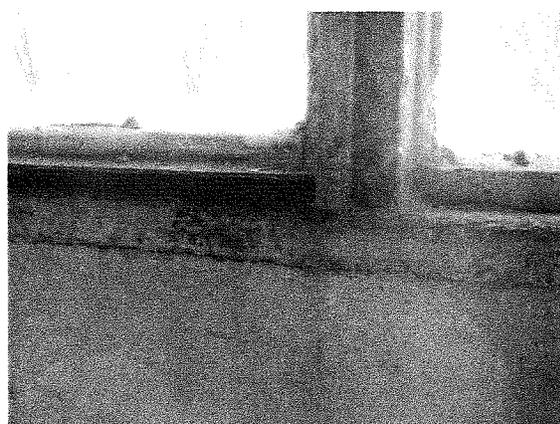
- Window glazing

HA No.	Description	Material Location	Percent/Type Asbestos	NESHAP Classification	Condition	Estimated Quantity
3	Window glazing	Windows	4% Chrysotile	Category I non-friable	Good	100 LF

Photo #5 HA 3 – window glazing on windows of former auto repair shop

It is recommended that the identified ACM at the site be managed in place with an Operations and Maintenance (O&M) Plan. ACM that will be disturbed during future renovation or demolition activities should be properly removed and disposed by a trained and licensed abatement contractor.

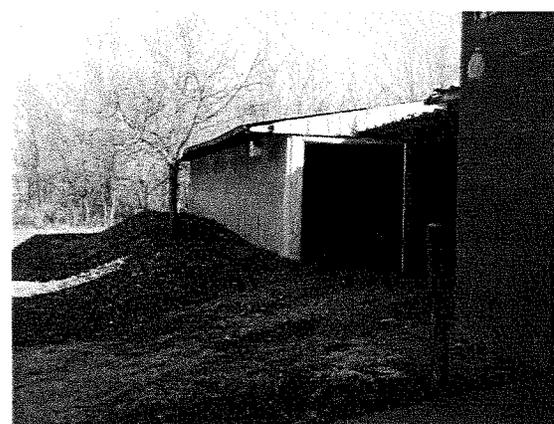
Photo #6 View of on-site barn

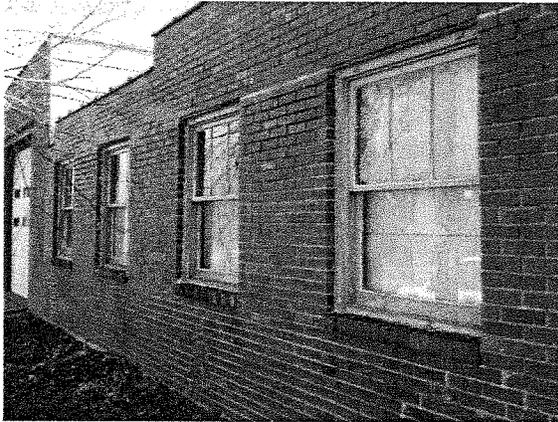
Photo #7 HA 4 – window caulk on exterior windows on north side of former auto repair shop

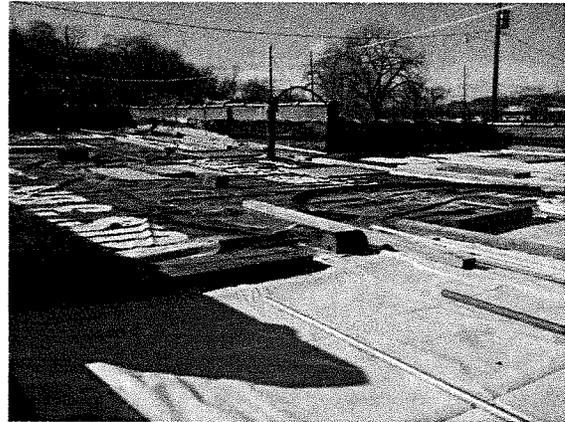
Photo #8 View of roof with plastic sheet covering

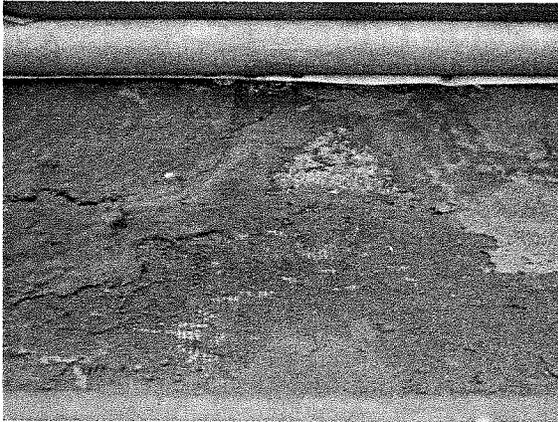
Photo #9 HA 5 – roof of former auto repair shop

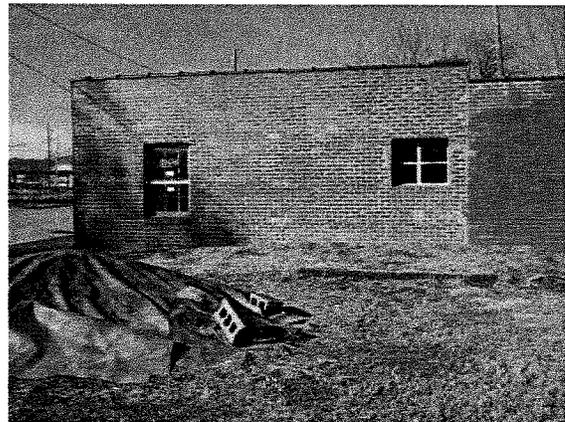
Photo #10 View of south side of former auto repair shop

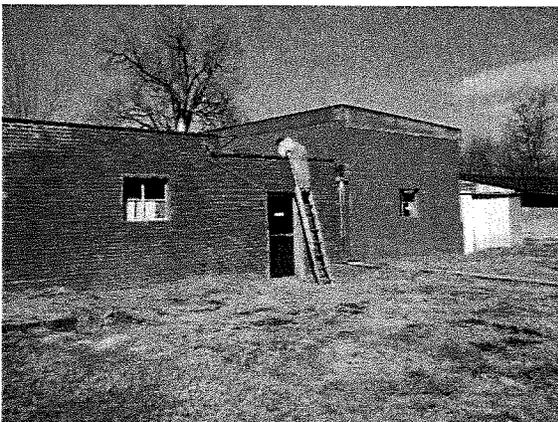
Photo #11 View of south side of auto repair shop, storage shed, and barn
