Asbestos Survey and Limited Lead-Based Paint Survey

The Display Center

929 Warren Barrett

Terracon Project No. 15107089

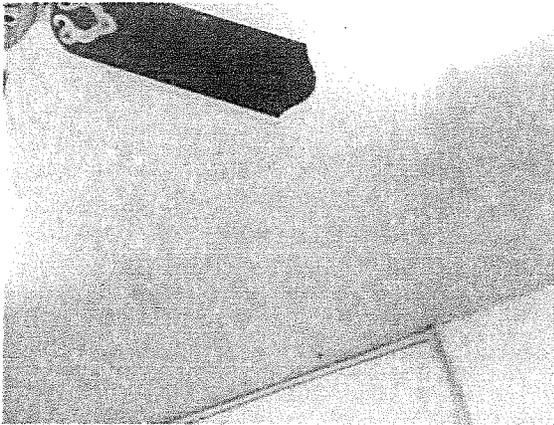
Photo #1 Drywall texture in The Display Center Office.

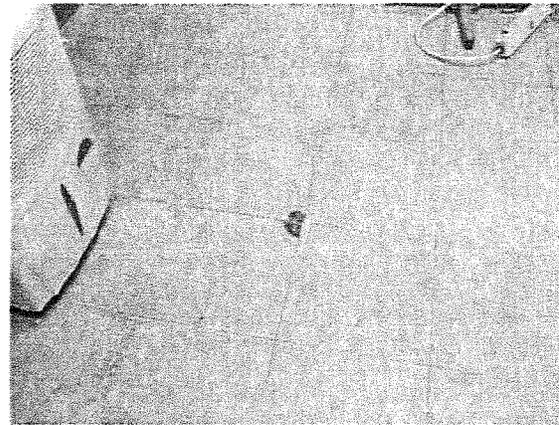
Photo #2 Floor tile and mastic in The Display Center offices.

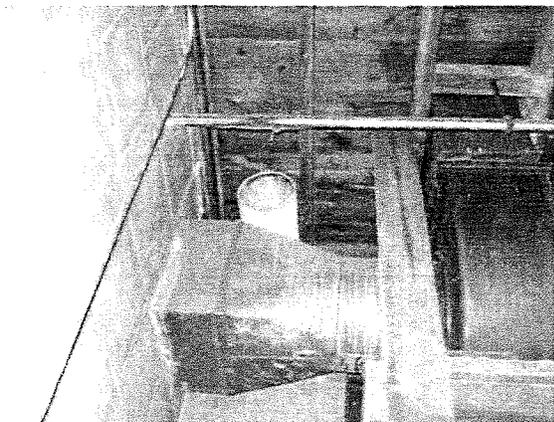
- Cement pipe – South warehouse
- Built-up roof – Conveyor / Gas Dryer Building

Photo #5 View of HA 14 - assumed cement pipe in warehouse

It is recommended that the identified ACM at the site be managed in place with an Operations and Maintenance (O&M) Plan. ACM that will be disturbed during future construction or demolition activities should be properly removed and disposed by a trained and licensed abatement contractor. The roofing material can remain on the Conveyor building during demolition. Category Non-friable I Asphalt roofing material is not regulated by the Missouri Department of Natural Resources (MDNR) as long as the material is in good condition and is not made friable during removal or demolition.

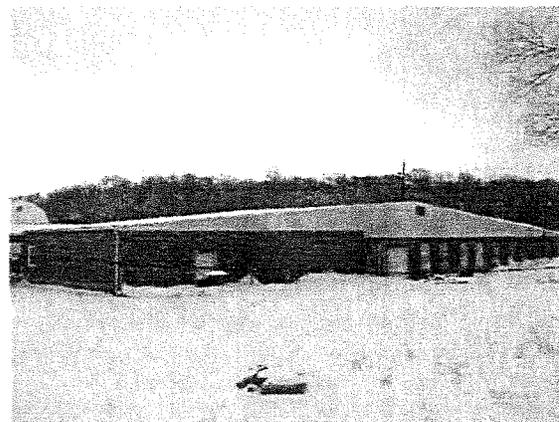
- Window glazing – Old Bus Barn, Loading Dock, North wall of Pattern Shop
- Window glazing – South warehouse

Photo #6 View of south warehouse building.

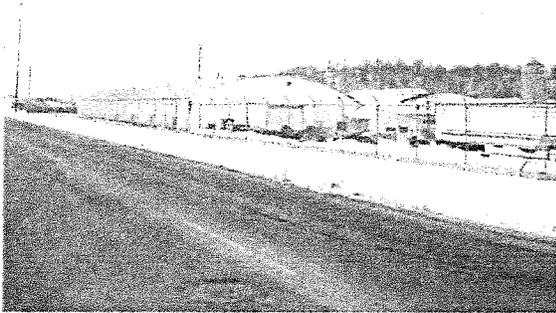
Photo #7 View of the Old Bus Barn (current Clearbridge Display Assembly)

The abatement of approximately 1,000 linear feet of window glazing (Old Bus Barn -10 windows, Loading Dock – 2 windows, North Wall Pattern Shop and Vacuum Forming – 8 windows) 1,400 linear feet of window glazing (22 windows – South Warehouse), and ten linear feet of asbestos cement pipe (South Warehouse) may cost between \$14,000 and \$17,000. The 5,300 square feet of assumed asphaltic roofing can remain on the Conveyor/Gas Dryer Building C during demolition as long as the material is in good condition and is not made friable during removal or demolition.

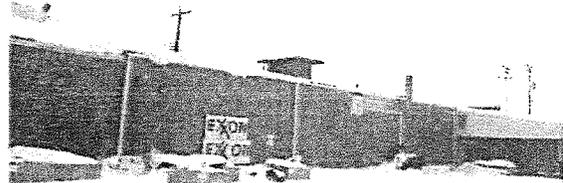
Photo #8 View of former conveyor/gas dryer building with built up roof
